Investigating the Geoenvironmental and Climatic Impacts on the Facades of Historical Houses in Killit (Dereici) Village, Mardin

Citation: Karataş, L. & Dal, M. (2023). Investigating the geoenvironmental and climatic impacts on the facades of historical houses in Killit (Dereici) Village, Mardin. *Journal of Architectural Sciences and Applications*, 8 (2), 1046-1061.

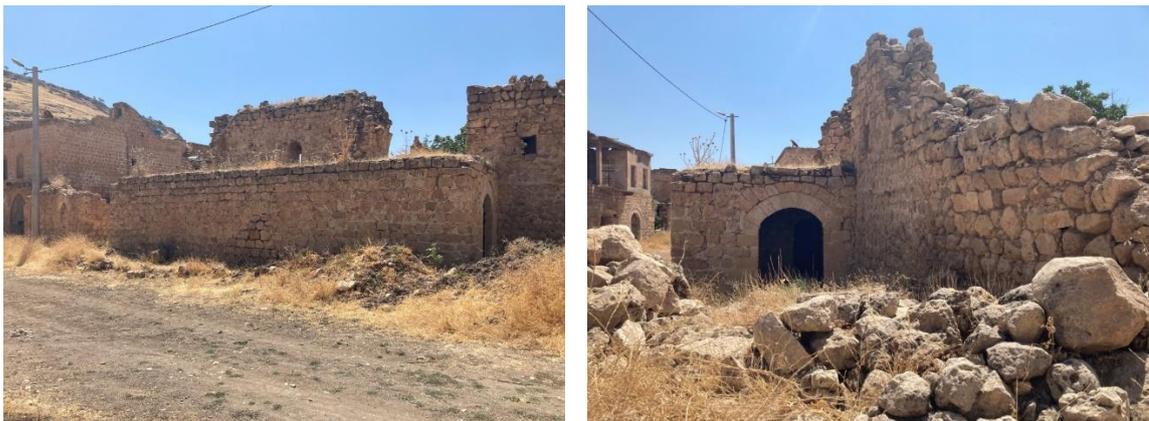
Figure 7. Deteriorations observed on parcel 1-2 of plot 179

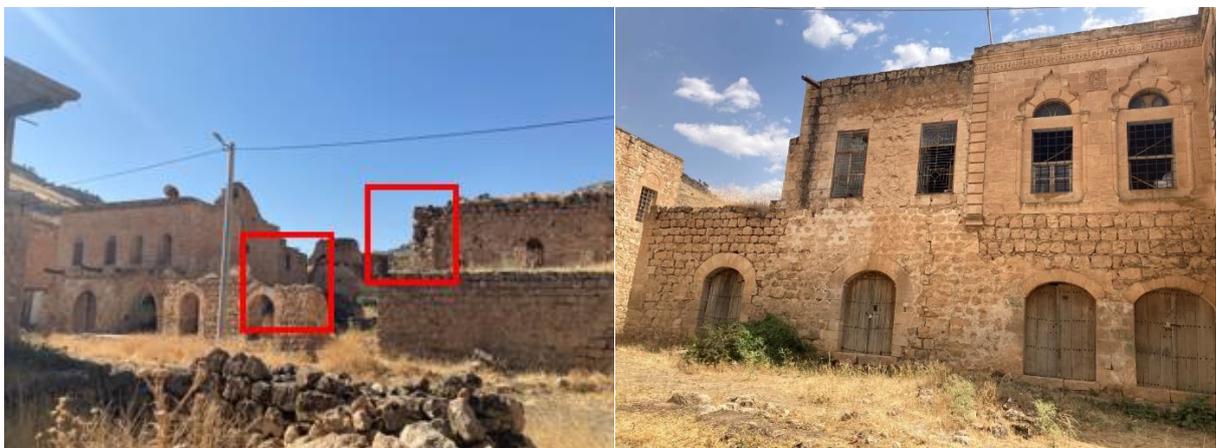
The main building material of structures, which is stone, features smooth limestone used in the arch stones, window and door openings, and facade corner joints. Four of the upper-level window openings on the south facade of the parcels have wrought iron railings, and the surroundings of the window openings are adorned with material made of smooth limestone. The upper right part of the south facade is enriched with facade ornamentation and decorative elements using smooth limestone. Additionally, this part of the facade is terminated with a profiled sill and parapet stone made of smooth limestone. Iron railings that deviate from the original texture are used on the windows of the south facade of the parcel. A garden gate made of wood that deviates from the original texture is seen in the garden wall. On the ground floor of the parcel, on the left side, there is a wooden door with an ornate stone arch. Next to it, passing through a pointed-arched eyvan, there is a low-arched wooden door. On the upper floor, there are four circular-arched windows with smooth limestone. The upper floor is terminated with a row of sill and parapet stone. There are three decorative elements on the facade surface. On the protruding rubble stone wall between the entrance floor and the first floor, plant formations can be observed. The stone surfaces exposed to atmospheric conditions for an extended period show darkening. Cement-based material has been used in the joints on the facades (Figure 7). Corrosion is visible on the iron railings that have reached the present day. Large-scale disintegration is observed on the facades of the structures. Advanced levels of erosion issues are observed on the stone surfaces (Figure 8).

Figure 8. Deteriorations observed on parcel 3-4-5-6 of plot 179

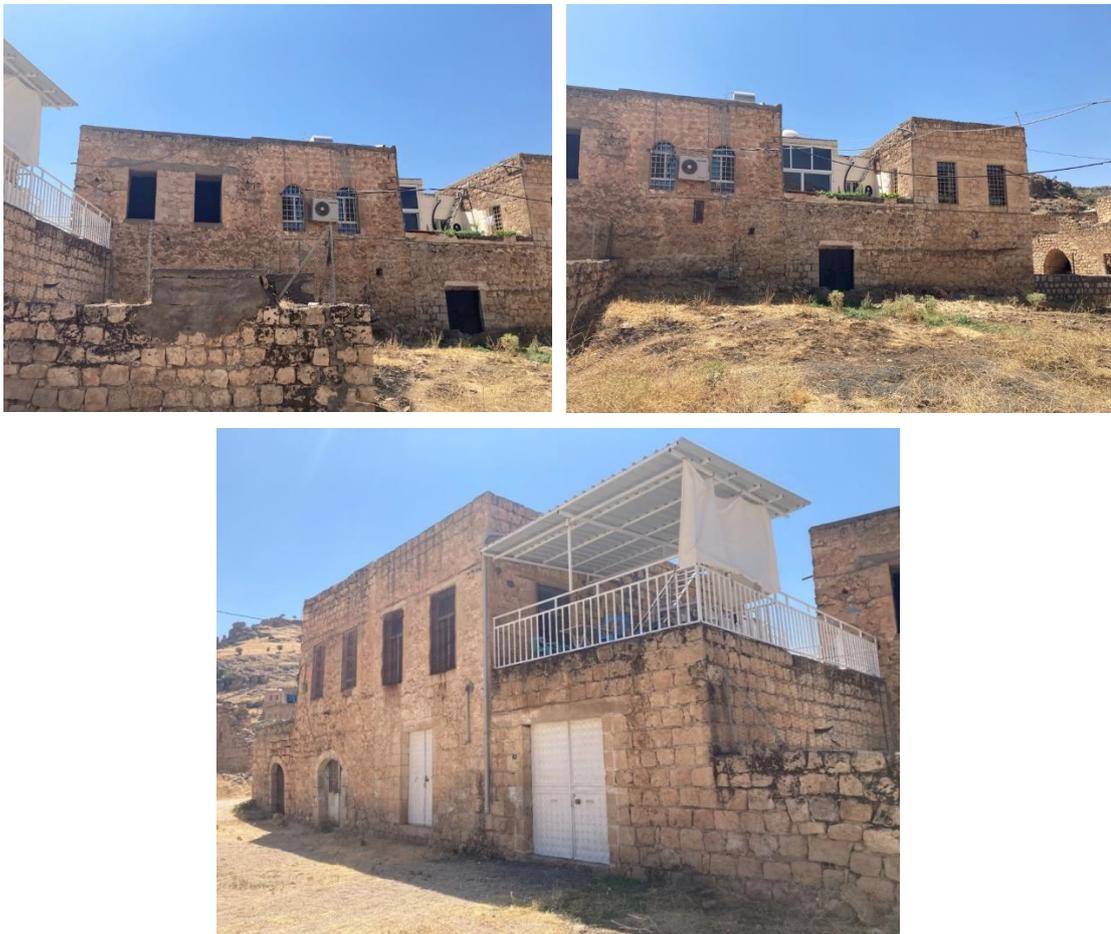
In the Savur region on the facades of the structures, there is a significant occurrence of mortar voids between the joints and the problem of 'missing parts' on the facades. The walls of the structures exhibit a significant issue of "discoloration." Additionally, the street facades on the northern side, which do not receive direct sunlight, show a lesser extent of deterioration. Another observed form of deterioration is the use of cement mortar to connect and fill the large cracks and missing parts in many of the stone blocks used in some facade walls (Figure 9).

Figure 9. Deteriorations observed on parcel 3-4-5-6 of plot 179

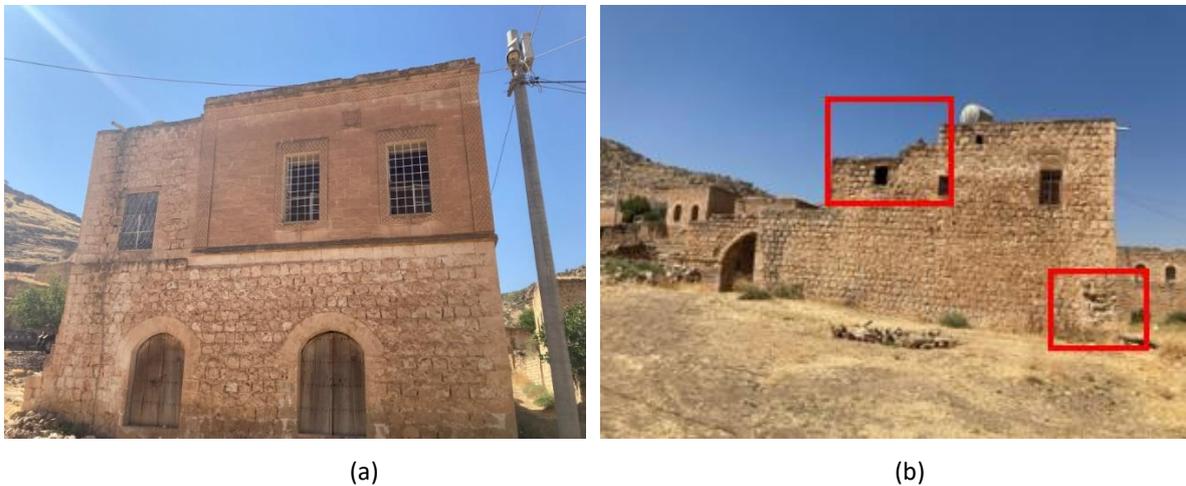
The examined parcel is currently not in use. Discolorations are observed on the stone surfaces exposed to atmospheric conditions for an extended period on the facade. Cement-based material has been used in the joints on the facades. Collapses are observed in the staircase leading to the upper floor. Corrosion is visible on the iron railings that have reached the present day. Damage and deteriorations are observed in the wooden veneer doors. Unqualified fillings are observed inside and around the structure. Poorly executed window openings have been added later to the east facade of the structure. Two iron doors that deviate from the original texture have been installed. Window railings that do not conform to the original texture have been applied on the facade surfaces. Large-scale disintegration is observed on the facades of the structures (Figure 10a). Particularly, these damages are more prominently observed at the junction points of the walls and at the highest points (Figure 10b).

Figure 10. Deteriorations observed on the facade of parcel 1 on plot 186
