## Classification of Physical, Chemical and Biological Deteriorations Observed in Ankara Stone Monuments

Musa Tokmak<sup>1</sup>, Murat Dal<sup>2\*</sup>

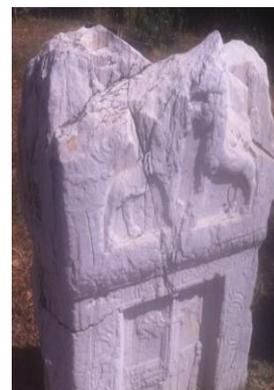
**Figure 2.** Loss of material on the upper part of the stone due to physical decomposition in Roman tombstone of the Roman period

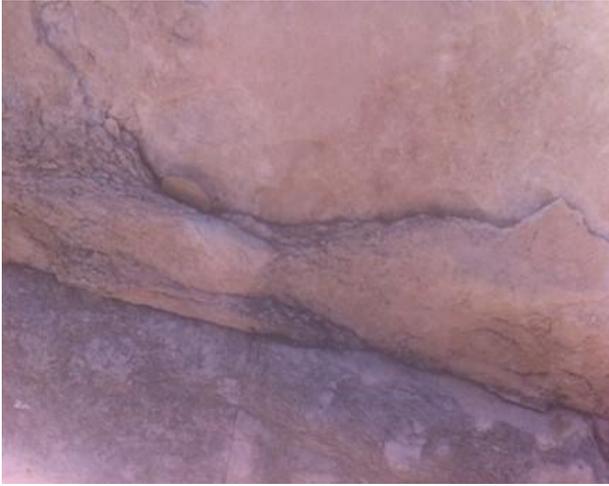
This type of deterioration is particularly intense in areas where there is physical detachment. This kind of decomposition is dominant in places where the temperature difference between day and night is great as well. Such deterioration problems are also present on the lower surfaces of the Augustus temple (Figure 3).

**Figure 3.** Ruptures that are the type of physical decomposition observed on the lower surfaces of the Augustus temple

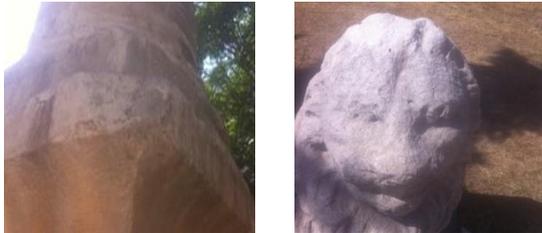
Factors such as rainwater and wind can lead to the loss of a proportional form of material on the surface of the stone, and the shapes and letters on the surface of the monument stone disappear over time. Such distortions are called "roundness (Rr)". The material loss of the lion statue in the Roman baths can be seen, especially due to the rounding in the face part (Figure 4).

**Figure 4.** Distortion of roundness due to erosion in the face of a lion statue in Roman baths remnants

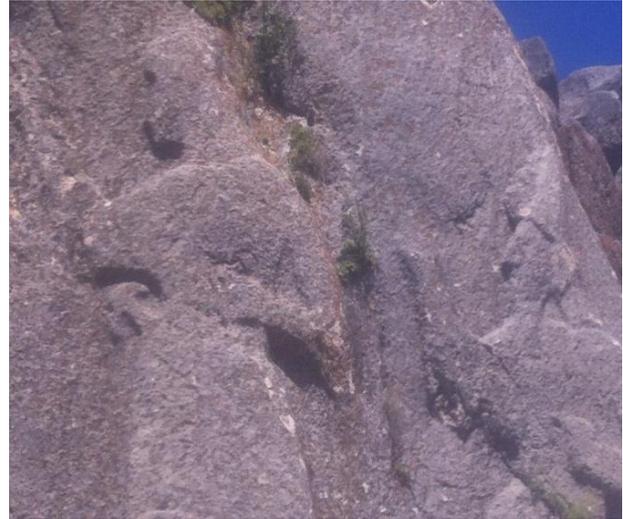
The greatest damage of the roundness is seen in Hittite figures in Gavurkales and the figures of Hittite soldiers are stripped from the stone surface due to erosion and lose their original shape (Figure 5).

**Figure 5.** Loss of material due to deterioration and rounding of Hittite military figures in Gavurkalesi over time from the original form

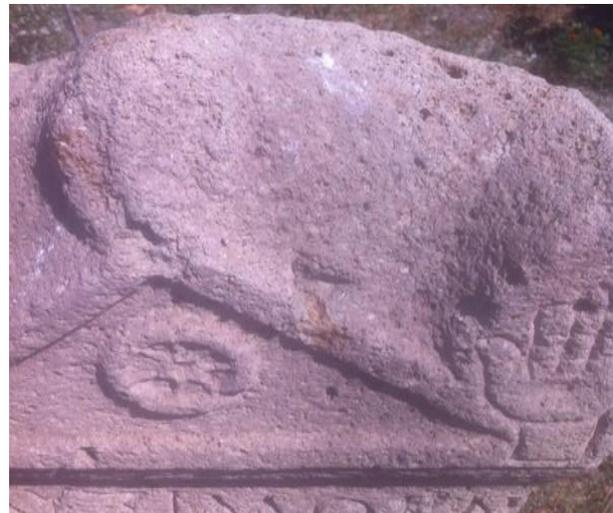
a loss of material in corners. In the picture below, rounding is shown on the upper surface and edges of the Roman andesite stone block of the Roman period (Figure 6).

**Figure 6.** Deterioration resulting in loss of material due to deposits on the andesite stone inscription in the Roman bath remnants

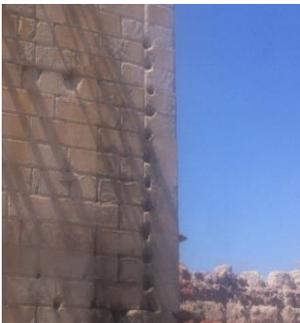
the surface of the stone over time and may come to break on the surface of the stone. In particular, due to the restoration of the surface of the Augustus temple, too many holes were opened (Figure 7). This is why material losses are common. Such deterioration can also trigger other types of deterioration. For example, chemical substances may accumulate in the stone pits due to atmospheric pollution (Figure 8).

**Figure 7.** Loss of material from the stone surface due to holes in the surface of Augustus temple due to structural reasons. Particularly the stratification (accumulation) of the black color around the holes

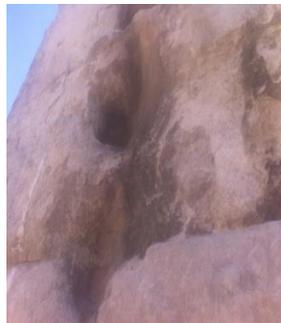
**Figure 8.** A close view of the holes on the surface of the Augustus temple. Due to the atmospheric pollution, black-colored accumulation clearly visible around the holes

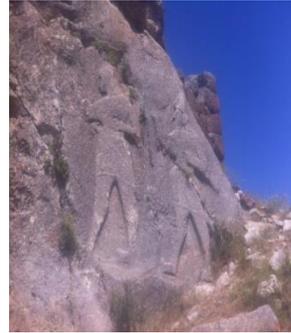
There are subgroups of this type of degradation. The subgroups are the “color change of the stone surface” and “accumulation of chemical substances on the stone surfaces such as dust and various kinds of organic and inorganic substances”. The plant roots between the gaps and cracks of the stone on the surface can cause physical/chemical/mechanical deterioration on the surface (Figure 9). Plants on the surface of Gavurkalesi were observed and these plants emerged in cracked areas caused some small cracks.

**Figure 9.** Plant colonization in the cracks on the surface of Gavurkalesi stone block

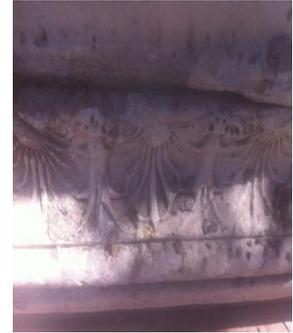
Drip type deterioration was seen especially in the Augustus temple. Pigeons are a threat to the Augustus temple because the pigeons in the Haci Bayram mosque are fed by the visitors. The presence of water-soluble salts such as sulfate, nitrate and

**Figure 10.** Contamination caused by pigeon and bird feces on the marble surface of Augustus temple

phosphate in pigeon and bird feces causes deterioration in the type of contamination on the marble surfaces of the structure (Figure 10).

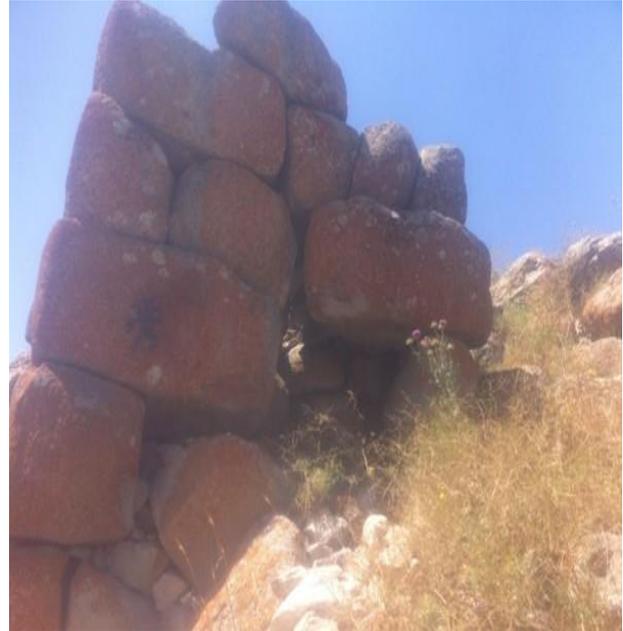
**Figure 14.** Lichen, algae, fungus occurrences in Gavurkalesi stone blocks

Gavurkalesi is situated in the rural area and it has more lichen-like formations, especially on the upper part of the stones around the monument. The most important factor is that the pollution in this area is less if compared with the city center. The influence of atmospheric pollution on historical monuments located in the center of Ankara prevents the accumulation of lichen, algae, fungus and algae colonization on these stone surfaces. Gavurkalesi is situated on a city away place that is not affected by pollution and traffic pollution (Figure 14).

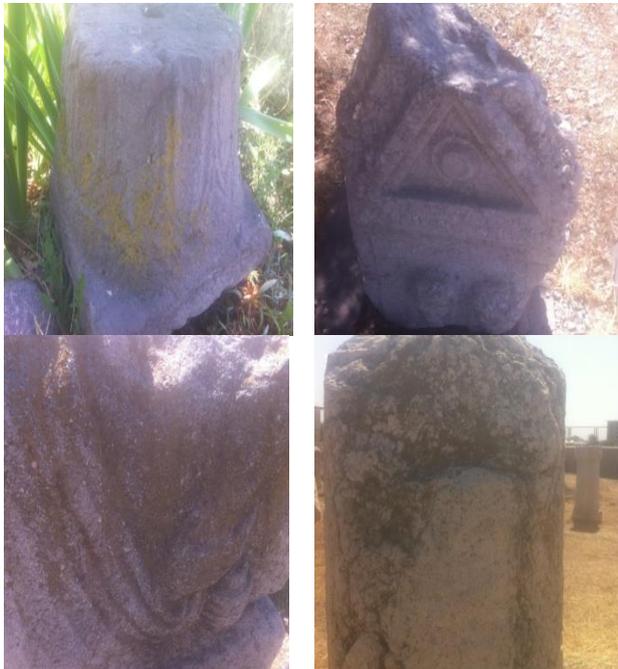
On the surfaces of many marble gravestones in the Roman baths remnants, lichen, black algae and mushroom-like biological colonizations are seen at the same time. In particular, lichens and algae-like biological deposits that appear on the sides and upper parts of marble stones can crack the stones and cause decomposition. Particularly those organisms that love moist areas prefer to use roof surfaces. Lichen and moss formed on the surface appear orange, black and yellow (Figure 13).

**Figure 13.** Lichen and algae occurrences on the tombstones of Roman baths remnants

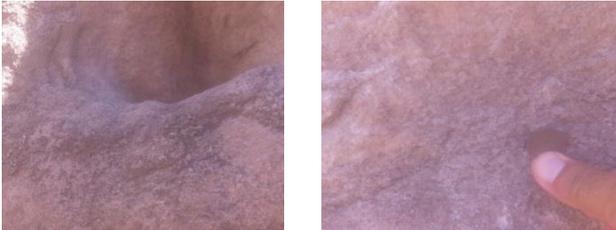
Granular/physical dissolution (dusting, crumbling, sanding), scattering, thinning, crusting, stratification and solubility of the rocks on the stone are the main subgroups. Granular dissolution is caused by the breakage of small pieces from the stones. Particularly, the breakdown of the stone surface is accelerated by the granular dissolution wind, which is due to salting, and the existence of rain, that is erosion. Such deterioration is particularly evident on the walls of the temple of Augustus, especially near the lower floor where moisture is present (Figure 15). There was no such deterioration in other monuments.

**Figure 15.** Granular disintegration on the walls of the Augustus temple. When touched by hand, some pieces are handled like sand

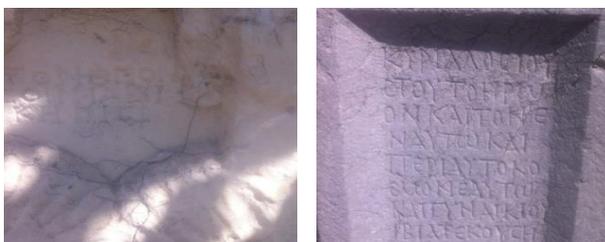
The thin and small cracks observed on the stones are also found on the basalt rocks forming the macro cracks Gavurkalesi (Figure 17), and on the marble monument stones in the remnants of the Roman baths (Figure 18).

**Figure 18.** Cracks on Roman marble monuments
