**PROSTHETIC REHABILITATION OF A PATIENT WITH WORN DENTITION: A
CASE REPORT***

Citation Information: Ucar E, Cekic Naga I. Prosthetic rehabilitation of a patient with worn dentition: a case report. J Dent Fac Atatürk Uni 2021; 31: 444-48.

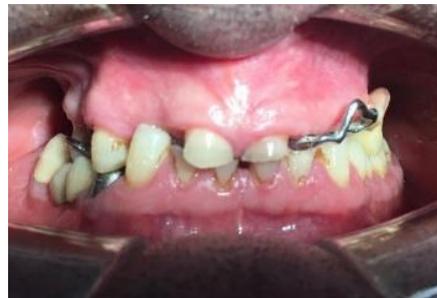
A 54-year-old male patient applied to the Gazi University, Department of Prosthodontics with reduced vertical size due to multiple tooth loss in the maxillary arch and tooth abrasion in both arches (Figure 1). The patient was provided an informed consent form. In the systemic anamnesis, there wasn't any sign of systemic disorders. Additionally, in the dental anamnesis taken, it was found out that tooth loss was caused by caries and there were complaints associated with clenching at night. In the intraoral examination, it was observed

that there was multiple tooth loss in the maxilla and mandible, and dentine was exposed in the incisal edges of the maxillary and mandibular anterior teeth. According to The Tooth Wear Evaluation System, the patient's occlusal and incisal abrasion was determined as grade 3 in sequences with reciprocal permanent teeth in occlusion. Non-occlusal and non-incisal abrasion were determined as grade 0.¹ Upon observing the insufficient crown lengths of the anterior teeth for fixed prosthetic restoration, final decision was to perform endodontic treatment for maxillary right central incisor, maxillary left central incisor, mandibular left lateral incisor, mandibular left central incisor, mandibular right central incisor, mandibular right lateral incisor. Extraoral examination resulted in key observations including decreased lower face height, drooping and over closed commissures and wrinkles around the lips due to OVD loss. In addition, no TMJ discomfort and pain in the muscles were reported in the joint examination. In the radiological examination, it was observed that the patient had sufficient alveolar bone support in the existing teeth and no pathology was found.

Figure 1. Intraoral view of the patient before treatment.

The patient's rest vertical dimension was determined using the Niswonger method and verified with the closest speaking space method. It was decided to increase the vertical dimension by 6 mm. The bite was opened 6 mm in the anterior region to ensure proper vertical dimension and to create enough space for a prosthodontic rehabilitation. Then, a diagnostic wax-up was prepared at the determined vertical dimension. After clinical and radiological examination, intraoral images of the patient were taken, and the patient was referred to the endodontic clinic for endodontic treatments. As a result of the complication experienced after endodontic treatment, the patient's mandibular left central incisor and mandibular right central incisor teeth were extracted.

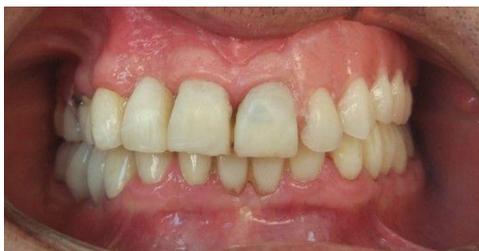
Figure 2. Intraoral view of the patient at increased vertical dimension with temporary prosthesis.

Following the endodontic treatment, prefabricated fiber posts were placed and preparations were performed. Subsequently measurements were taken with irreversible hydrocolloid impression material (Hydrogum, Zhermack, Badia Polesine, Italy) from the upper and lower jaws. Temporary crowns were prepared with autopolymerized cold acrylic (Alike TM, GC America, Alsip, IL). At the first stage of the rehabilitation, a provisional removable restoration was fabricated at increased OVD and temporary crowns were cemented with temporary cement (Temp Bond Netm, Kerr, Salerno, Italy) (Figure 2). During the period of two months, the patient was checked regularly and no muscle tenderness or temporomandibular discomfort was observed. At the end of two months, definitive impressions of the maxillary and mandibular teeth were taken with an additional silicone impression material (Elite HD, Zhermack, Badia Polesine, Italy). After the metal and dentin rehearsal stages, definitive impressions of maxillary arc were taken with irreversible hydrocolloid impression material (Hydrogum, Zhermack, Badia Polesine, Italy). Finally, group function occlusion was achieved. Restorations were permanently cemented with polycarboxylate cement (Adhesor Carbofine, Kerr, Salerno, Italy) and an appointment was arranged for the next day to remove the removable partial denture with extracoronary ball attachments (Dental Bredent Vario Soft Ball Attachment, Senden, Germany) under control (Figure 3). After oral hygiene training, the patient was instructed about how to use the removable partial denture and 3, 6, 12 months of controls were recommended. A significant improvement in the patient's facial profile was observed at the end of the treatment (Figure 4). During routine controls, prosthesis of the patient was evaluated with a review form. There were no signs of pain and discomfort in the joint.

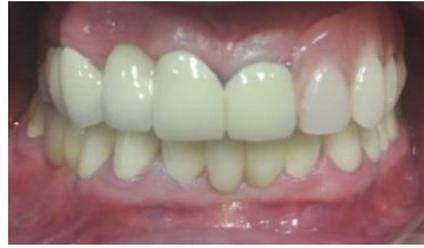
Figure 3. Post-treatment intraoral views showing restored teeth.

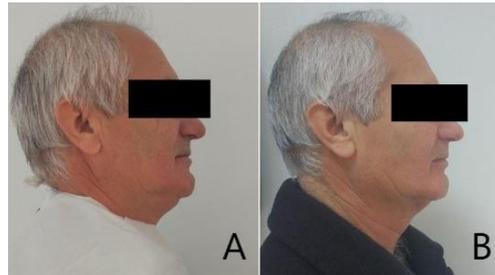
Figure 4. Post-treatment facial photographs showing the facial profile (A) before treatment (B) after treatment.

achieved. At the end of the treatment, both facial appearance, aesthetic and occlusion problems were resolved. Considering the profile photos at the end of the treatment and before the treatment, there is a significant change in the profile image of the patient and the height of the lower face reaches its proper position. The centric occlusion, protrusive movements, anterior guidance, and group-sparing function of the patient were checked. Since the patient's maxillary left canine tooth was not present, the function with group guidance was established. In addition, anterior guidance was especially paid attention, as it is a best practice to protect posterior teeth according to current theories.¹⁹

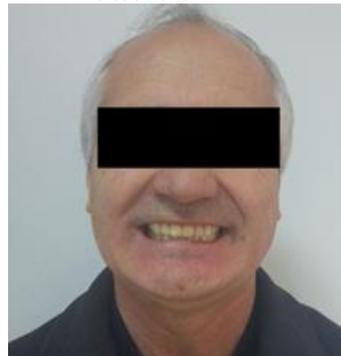
Figure 5. Post-treatment smile of the patient.

In this report, the patient firstly adapted to the temporary prostheses and the new OVD, and then a new occlusion with permanent prostheses was
